# A Garden Story

## Water, water everywhere!

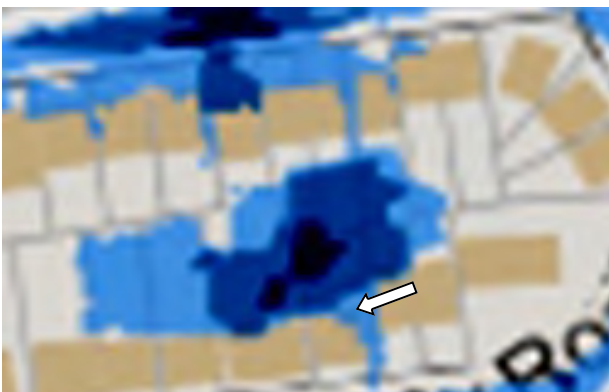
Environment agency map of surface flooding risk: the back gardens are in the middle, where the dark blue patch is, the surface flood water is predicted to find its way down my drive (bottom right).

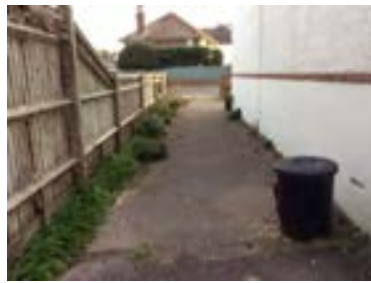
The way the drive was.....  
very prone to puddles!

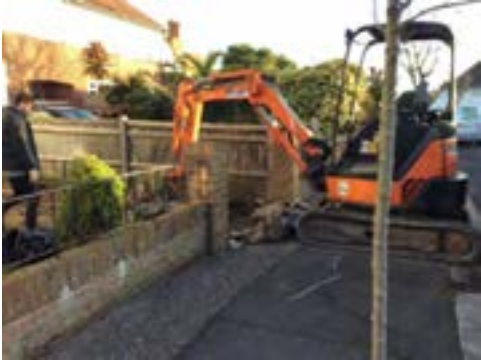
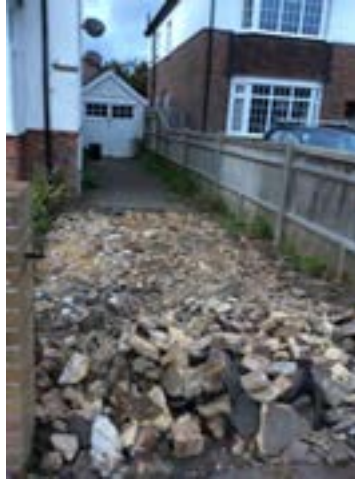
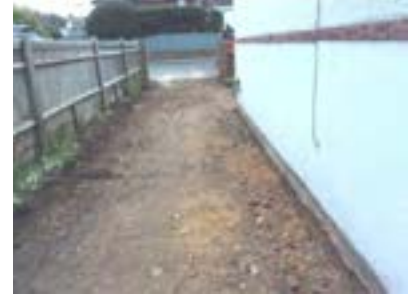
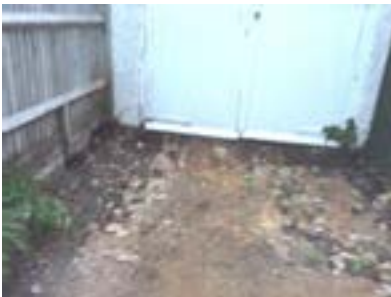
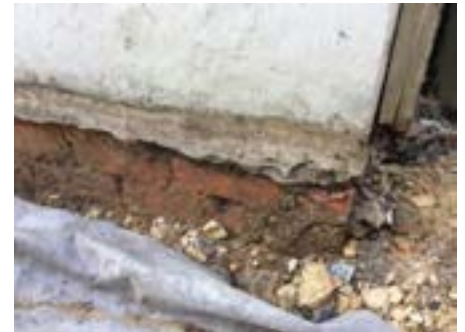
Demolishing the concrete drive, and removing lots of rubble, down to the foundations, before repairing the brick work.

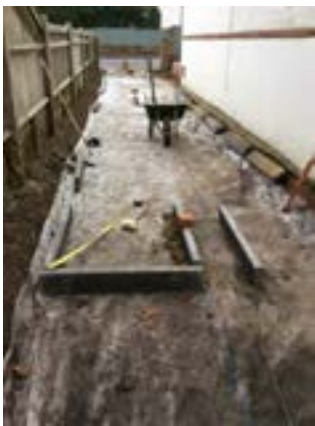
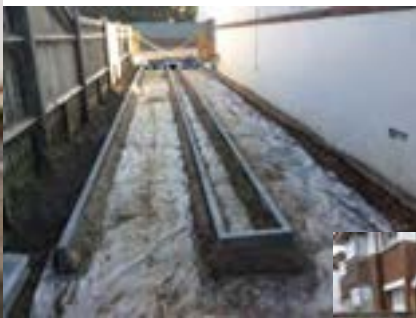
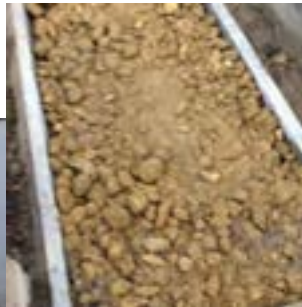
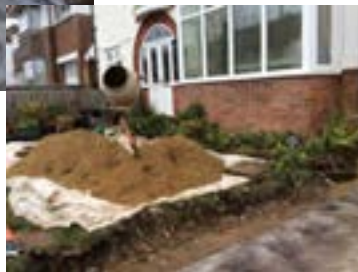
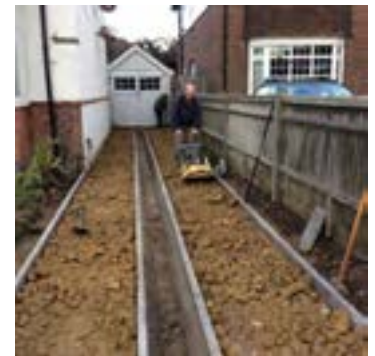
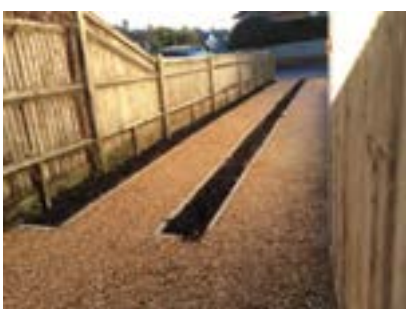
Laying a permeable sheet, topped with scree and heavy soil (hogging) that can retain water when flooding occurs, and laid between 'kerb pavings'. The layer is then compacted and topped by gravel, good enough to hold the weight of a car. The drive is now flat but slopes slightly down from the street level, as before.

The drive was re-laid using a permeable membrane, 'pavements' were filled with an absorbent mix, then covered with gravel. Flower beds on the side and middle of the drive were left, with soil, to add interest and planting options. Around the house thicker gravel was poured near the repaired foundations for better drainage.

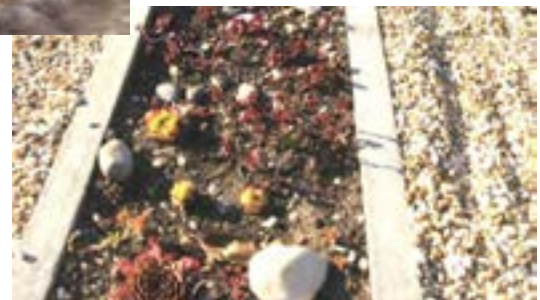
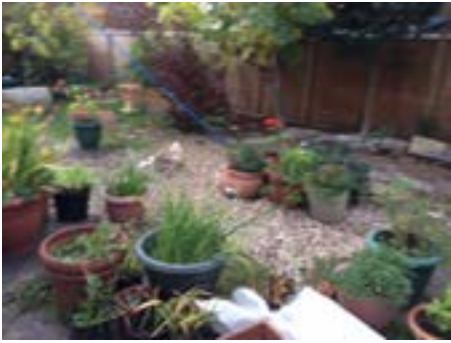
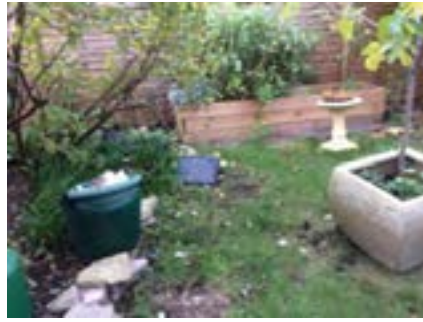
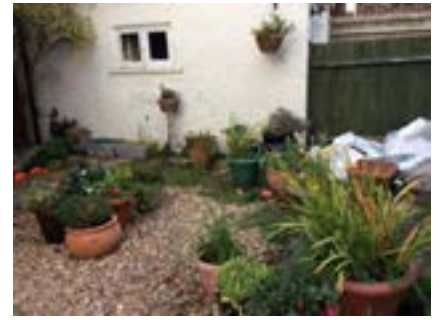
The finished drive,  
and right, adding some life to it .  
However it will take some time to grow!  
(June 2019)

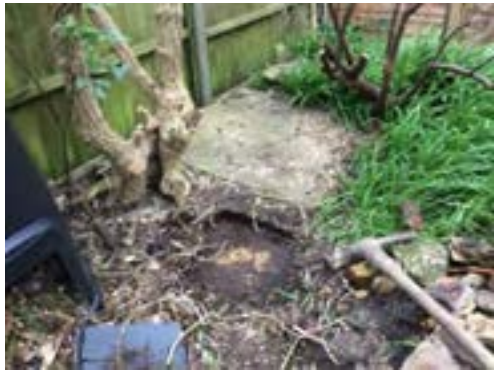
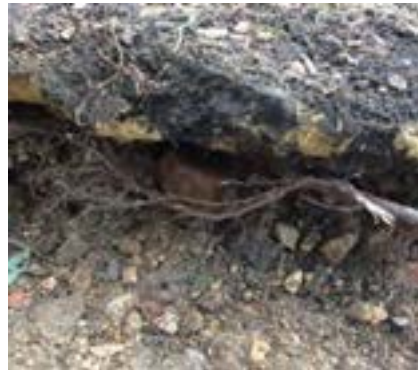
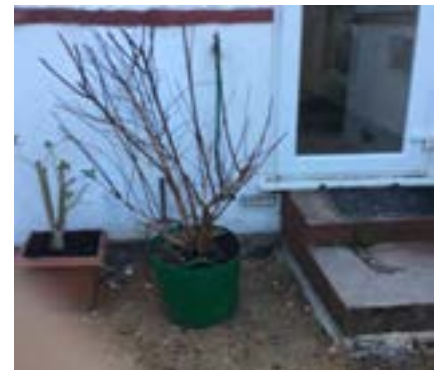
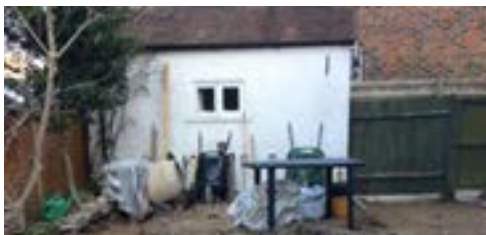
The back garden as it was, above. There was crazy paving around the back door, along the garage, under windows.

Below, the first clearing: removing about 30cm of builder's rubble, exposing the foundations, and more rubble below.

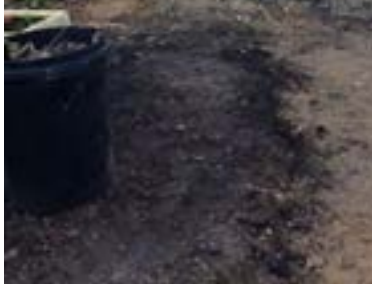
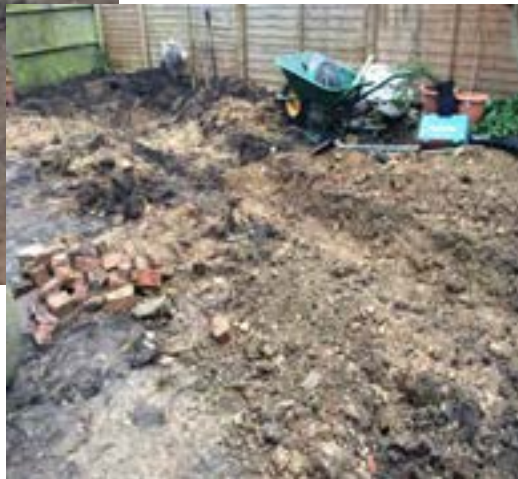
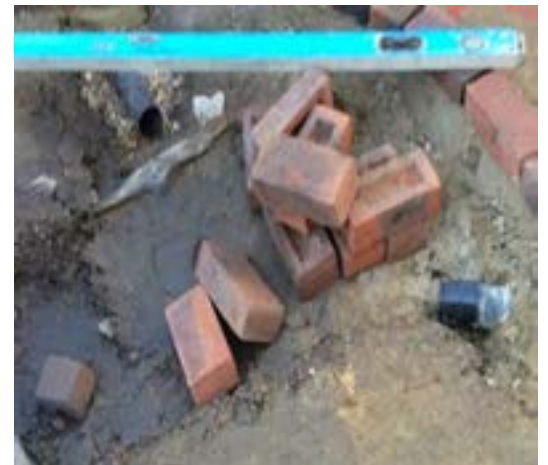
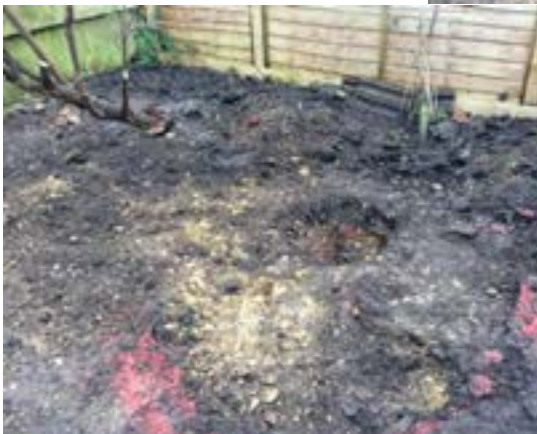
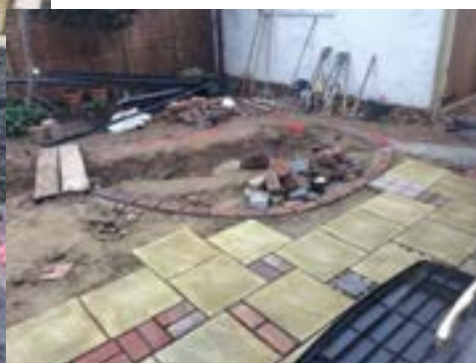
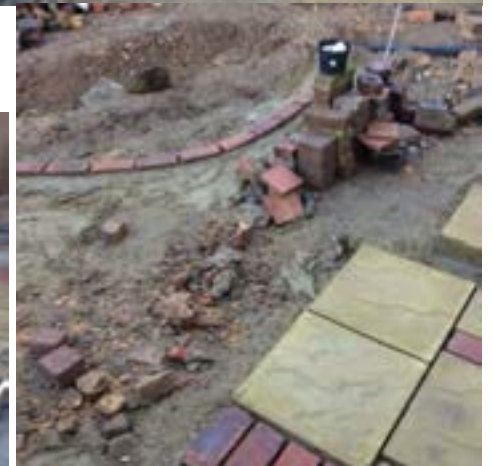
Marking the areas of the back garden, with sloped paving, the swale and pond areas, in order to contain excess water in case of flooding. The overflow from the butts are directed into the swale (below).

The vegetation in the back garden near the house showed clear signs of dampness as there is hardly any sun there for half the year. So it was decided to re-surface some of it, creating a slight slope, towards a swale and a pond area. The paved area was laid with at least 25% recycled material and porous filling in-between. On top of the swale, a pond lining was used, then clay, then new soil was added.

The pond area is designed to catch excess surface water and be mostly self-maintaining. Two overflow pipes from butts direct the potential surplus water to one of the swales. The pond has a clever system to catch or drain excess water at the bottom, with a plug, draining if required into a sump.

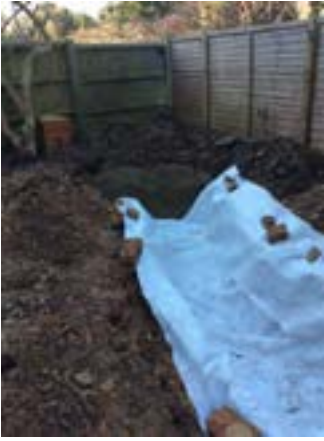
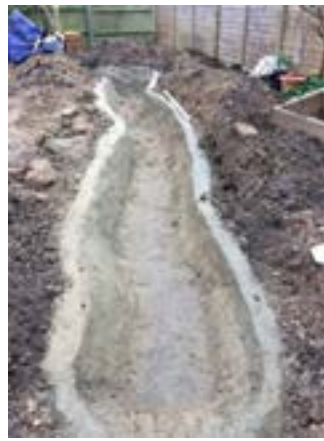
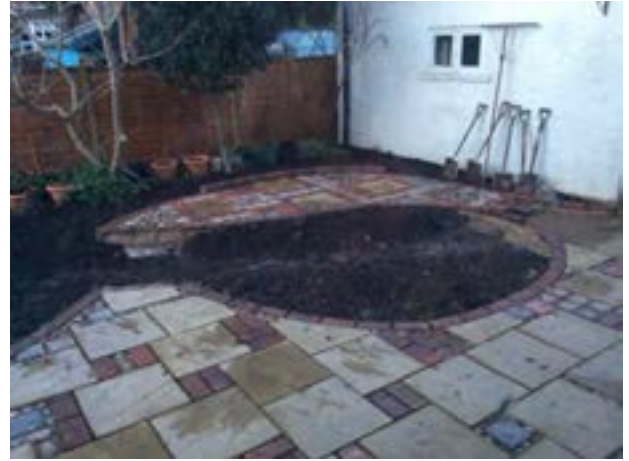
The back garden, and the swale taking shape.

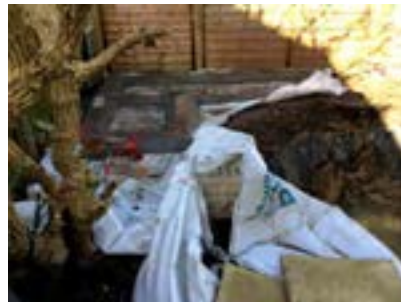
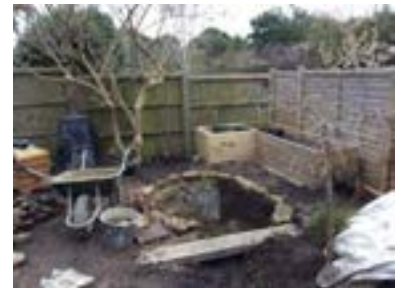
The beginnings of a pond, and the foundations for the vegetable boxes.

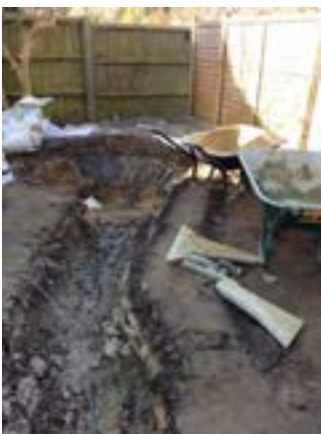
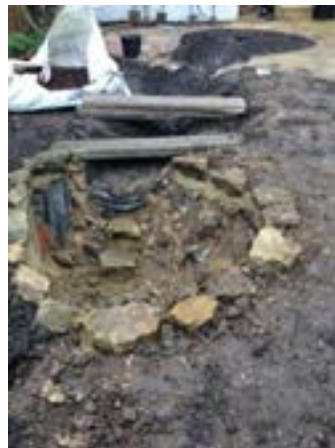
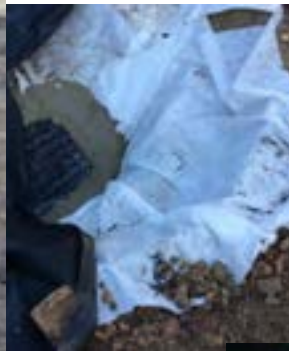
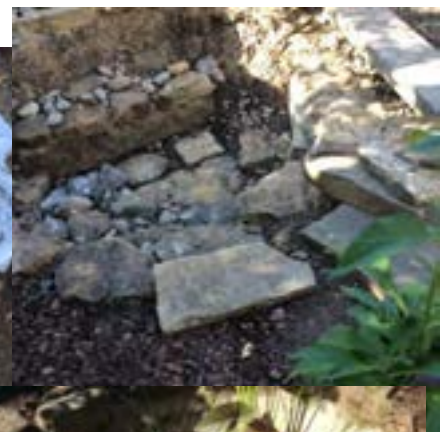
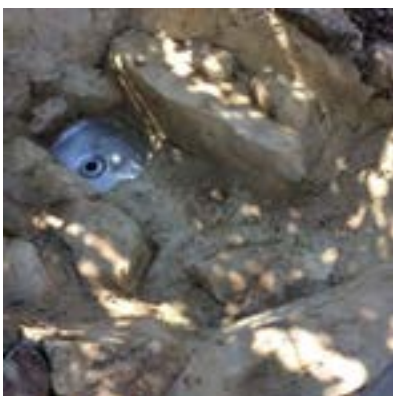
And now for the **pond** saga: The idea was to have an area where water could accumulate if need be. It is quite deep, about a metre deep with a sump at the bottom. Consequently, to allow wildlife to come in and out, stepping areas were added. The waterproof lining went momentarily over the sump area, and water some times accumulated there. However The pond being mostly made up of clay, with some earth added, deteriorated the first time it rained heavily, and the sides, being too steep started to shrink and slide when dry. So when it was time to test the sump system, thus making a hole for a plug, and inserting the bottom of an old sink with a plug, the water whilst circulating successfully up towards the slightly sloping garden, did not want to stay in the pond for long! Thus we had to move to solution number two: an impermeable resurfacing of the whole lot – twice. The finished pond so far is below (July 19)

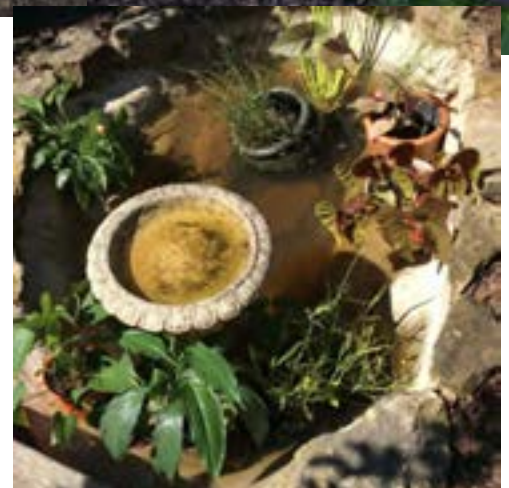
The pond in July, just filled, having added aquatic and other plants, and an old bird bath, in the water, to keep them safe from marauding foxes. Now it is waiting time, for newts, frogs, dragonflies to commute from another nearby pond.

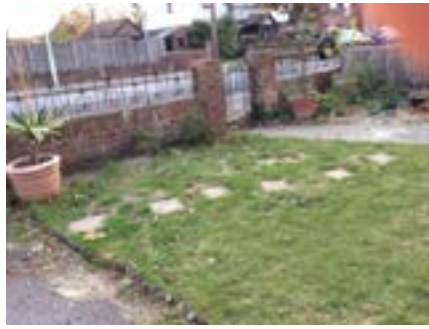
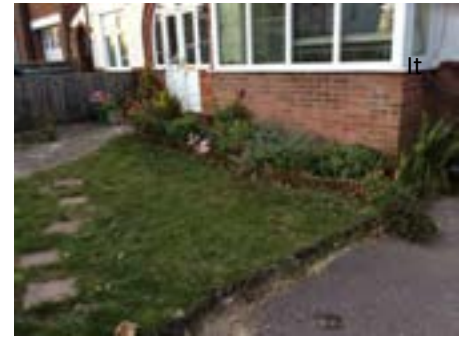
The front garden as it was, the stepping stones were there to avoid puddles when rains.

Under the window, the bricks have been repaired, the air bricks uncovered, an new planting has started.

The front boundary wall and fence were past their best, they came down with a few kicks!

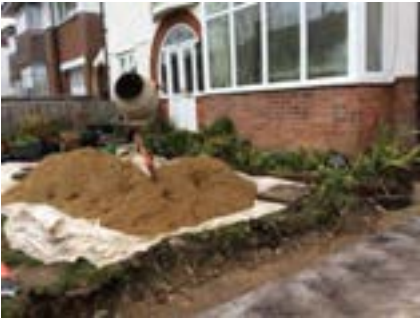
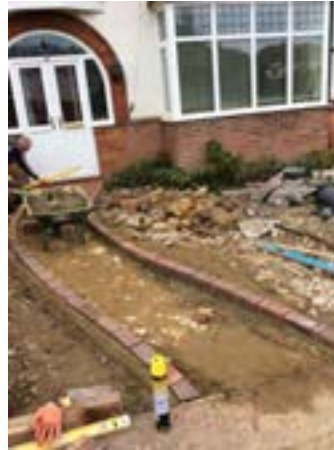
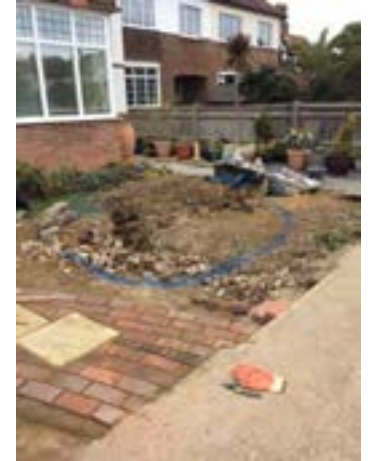
Below, the front 'lawn' whilst work is ongoing at the back of the house.

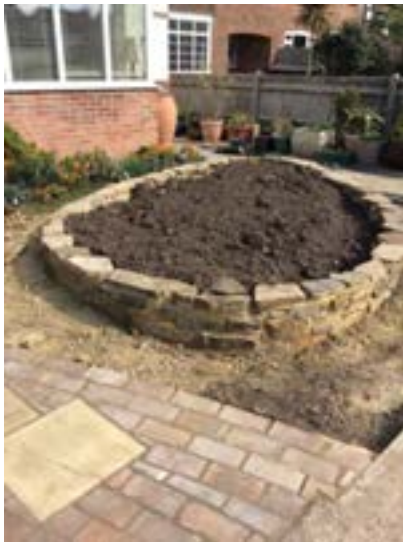
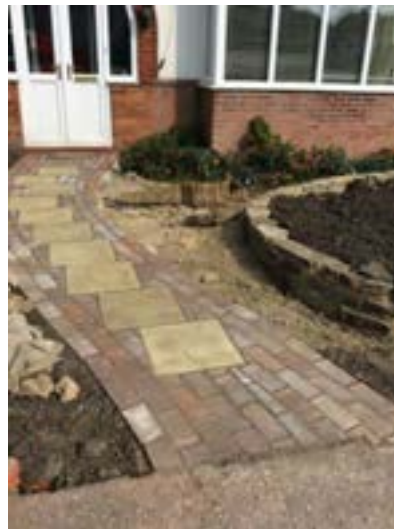
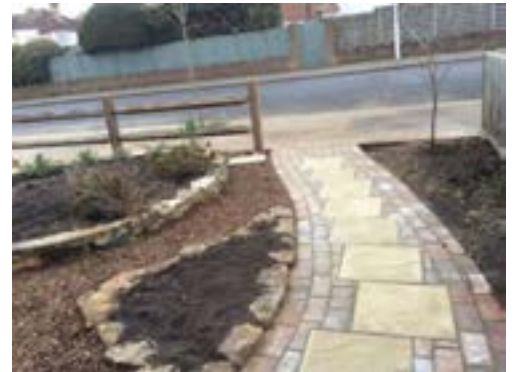
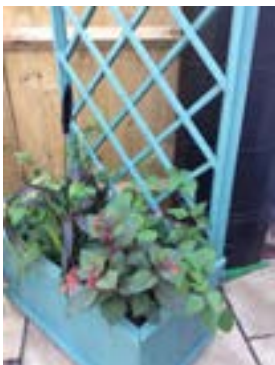
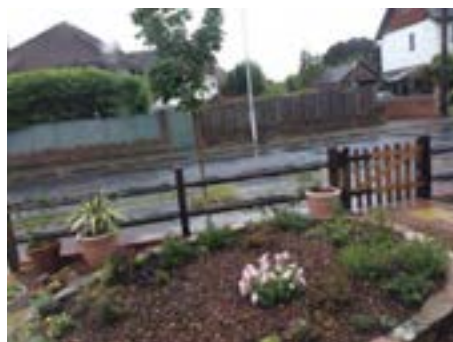
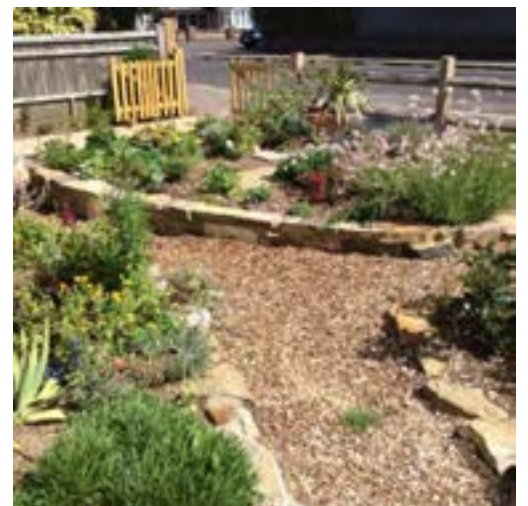
The path to the front door, redesigned and set higher, to avoid wet feet on rainy days. The thin layer of grass or stones were removed uncovering more builder's rubble. There was only one easy option left, that is to build a rain garden, recycling material from the garden and elsewhere, then using wood chips and bark. Now on a rainy day, the water stays out, or is easily absorbed instead of travelling towards the overflowing drains on the road. The new fence and gates were made to measure using some recycled wood.

A large oval was built, using old crazy paving for its wall, and good absorbent fertile soil was poured in.

The path to the front door was re-laid to avoid surface puddles whenever it rained, using the same material as that of the back garden. Flower beds were created along it, using stones recycled from elsewhere. The damaged front brick wall was demolished and many of the bricks were reused. It was replaced by a fence, and gates, some made of recycled wood.
